FINAL Baseline Property Condition Assessment

520 Ellesmere Road,
Toronto, Ontario

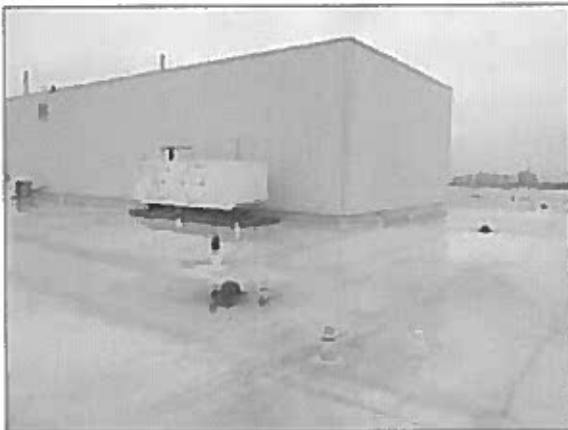
General view of the PVC single-ply membrane roof system noted on the main roof area.

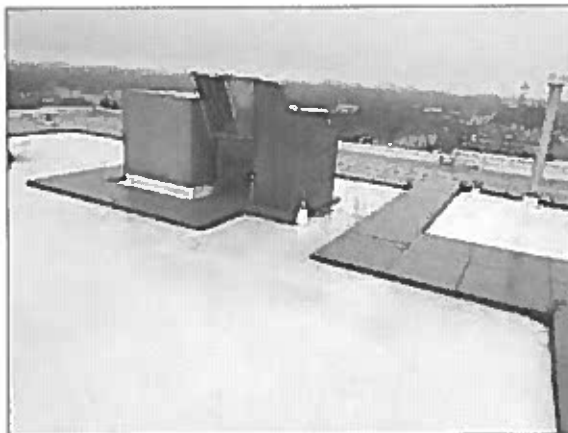
General view of the PVC single-ply membrane roof system noted on the upper roof area.

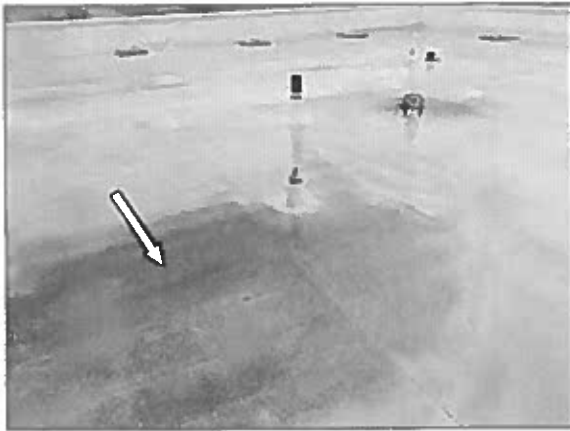
View of the water ponding noted on the main roof area.

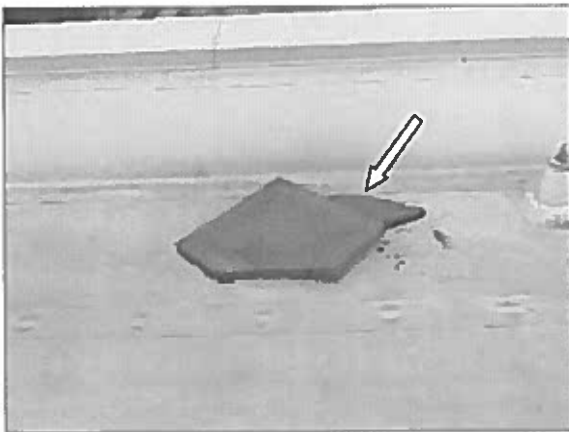
View of the broken concrete paver noted on the main roof area.

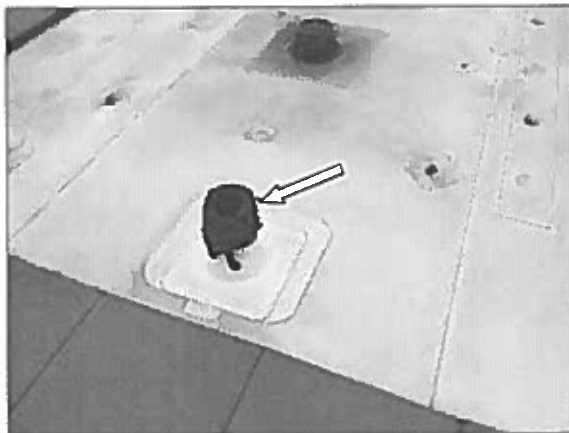
View of the plastic cover on the roof vent noted on the upper roof area.

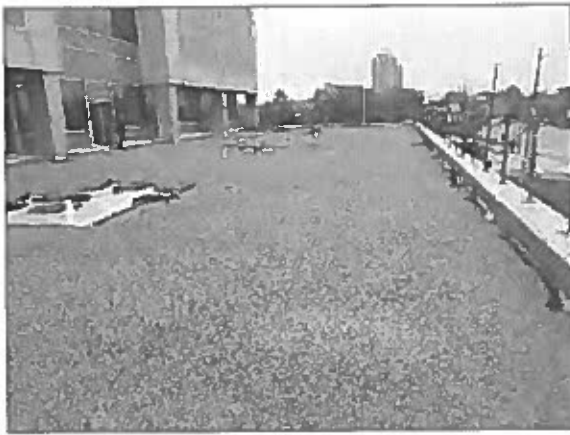
General view of the future green roof system overtop the PVC single-ply membrane roof system noted on the lower roof area atop the south portion of the Site Building.

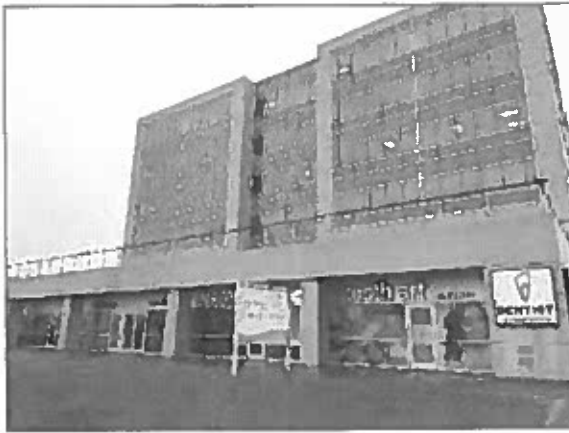
General view of exterior wall cladding of the Site Building.

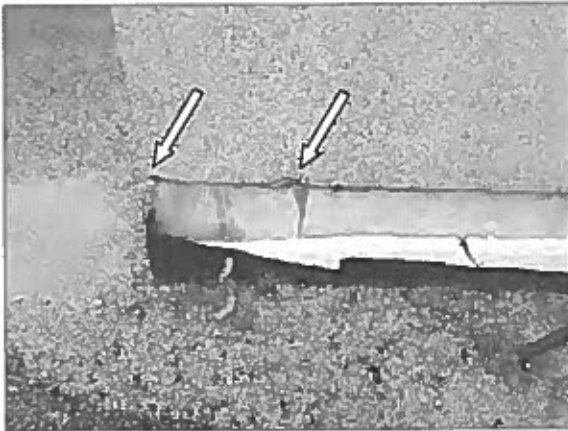
View of the chipped/damaged precast concrete wall panel noted on the west elevation of the Site Building.

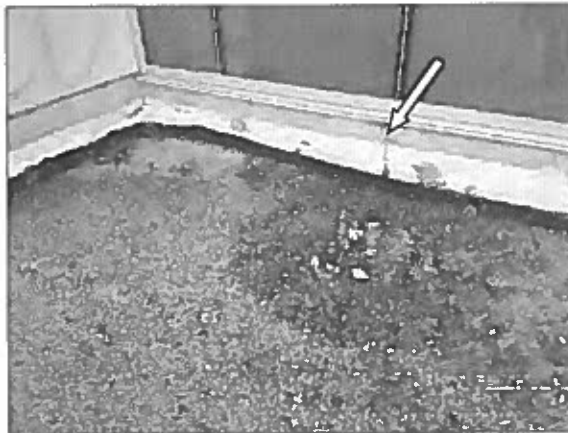
View of the damaged insulation boards and unfastened drainage boards noted on the north elevation of the Site Building.

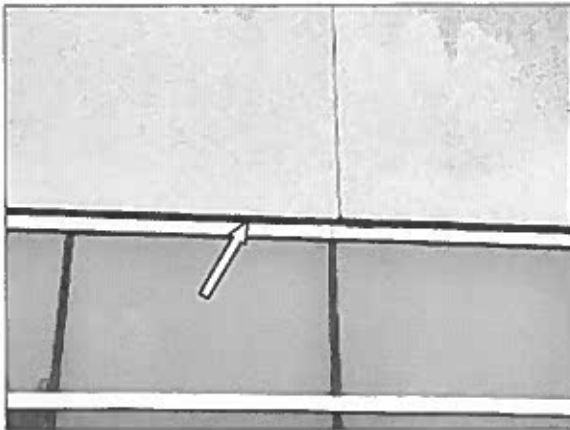
View of the missing window perimeter sealants noted on the west elevation of the Site Building.

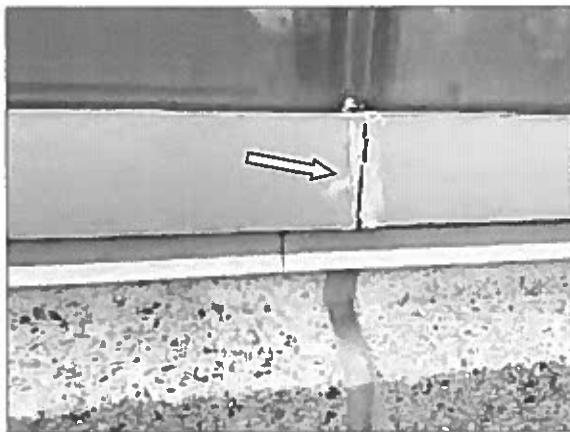
View of the deteriorated sealant in the window frames noted on the west elevation of the Site Building.

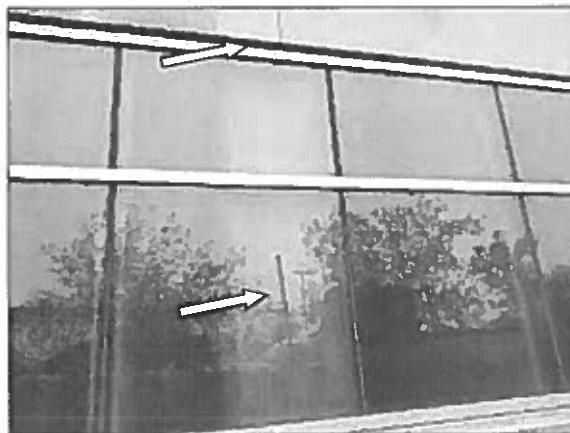
View of potential evidence of water infiltration (i.e., water staining on the gypsum wall boards) noted on the west elevation of the Site Building.

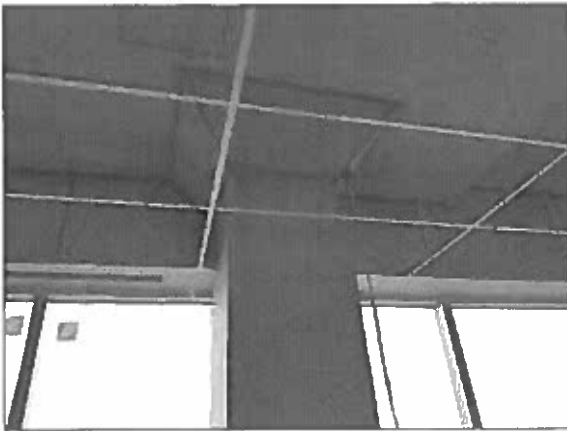
View of the reinforced concrete structure (i.e., column and capital) supporting a suspended concrete floor slab.

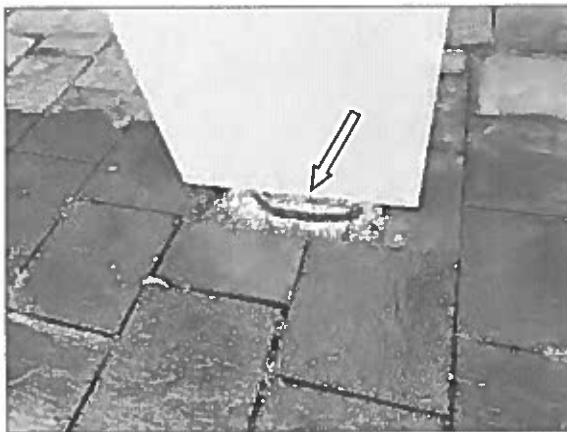
View of the exposed steel reinforcing bars in the concrete column noted adjacent to the south elevation of the Site Building.

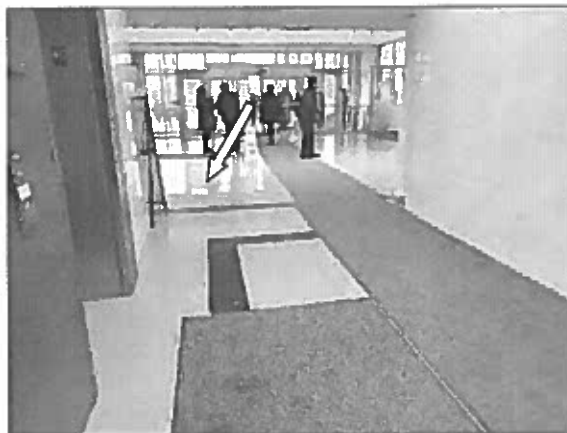
View of an anomaly in the concrete floor slab noted in the main entrance lobby.

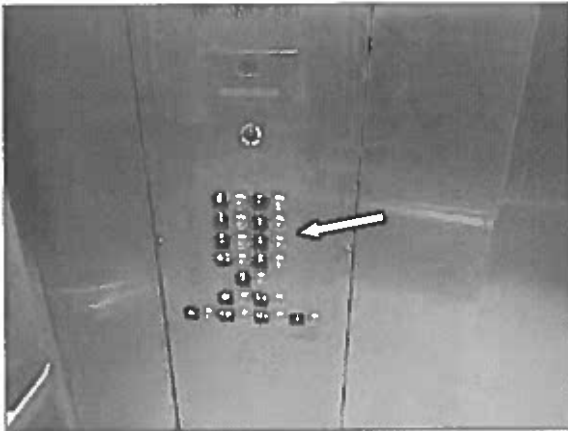
View of a typical elevator control panel within the elevator cab.

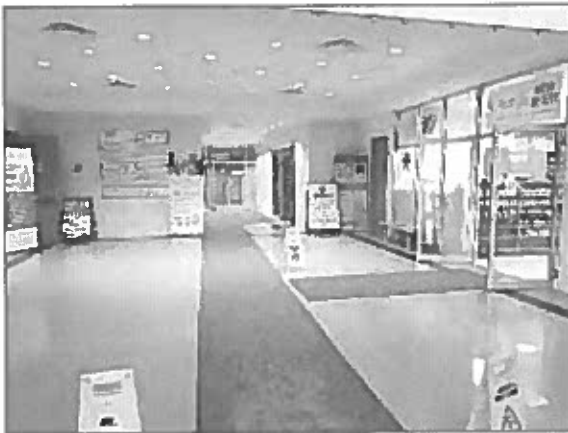
General view of the interior finishes in the main lobby of the Site Building.

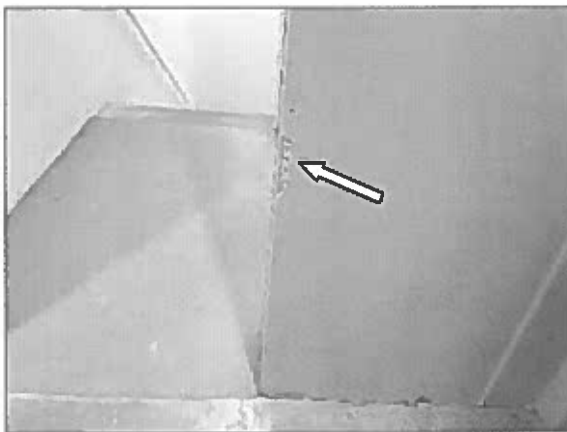
View of the damaged gypsum wall board noted in the stairwell of the Site Building.

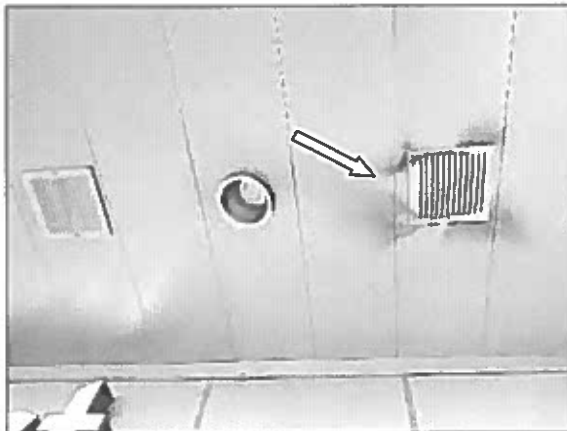
View of the staining on the metal ceiling panels noted in the main lobby of the Site Building.

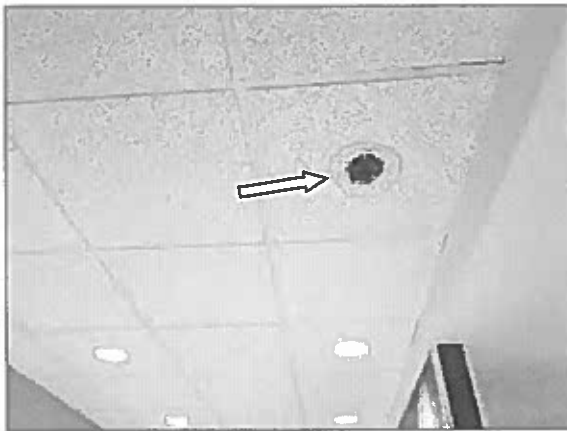
View of the water staining and black staining (i.e., potential mould growth) in the ceiling tile noted in the washroom of the Site Building.

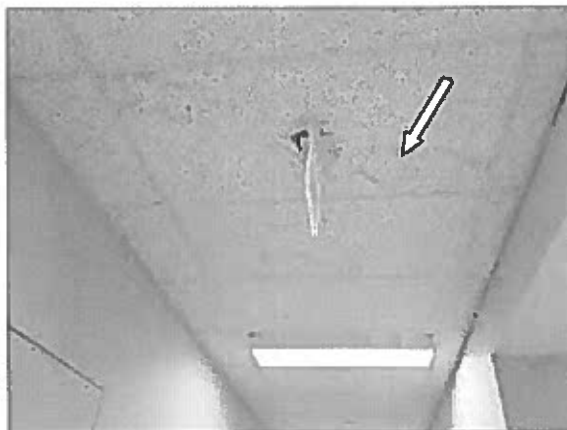
View of the water staining in the ceiling tiles noted in the corridor of the Site Building.

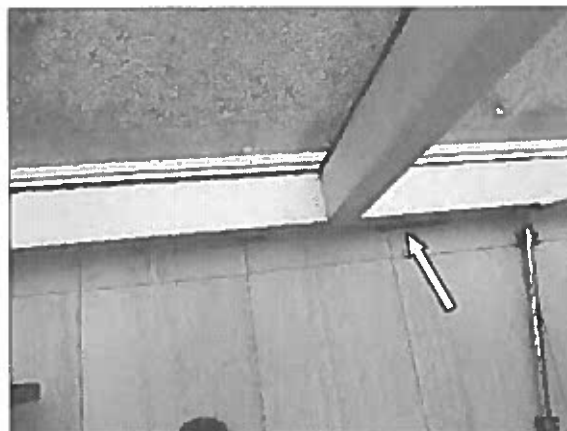
View of the cracked/missing tile grout noted in the ground floor level pharmacy.

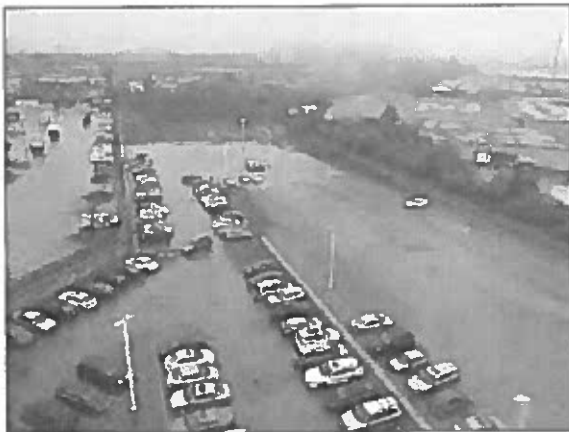
General view of the asphalt paved and gravel surfaced parking areas and driveways noted on the north portion of the Site.

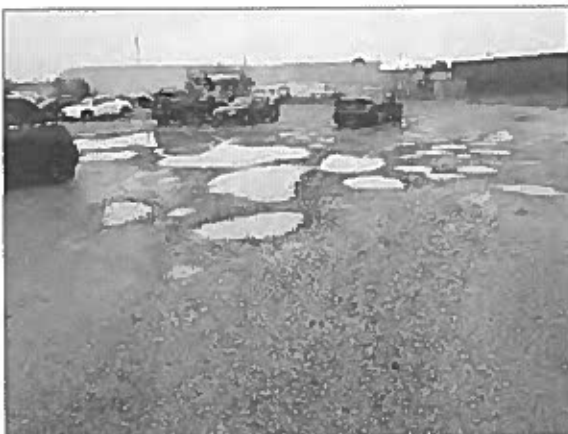
General view of the gravel surfaced parking areas noted on the north portion of the Site.

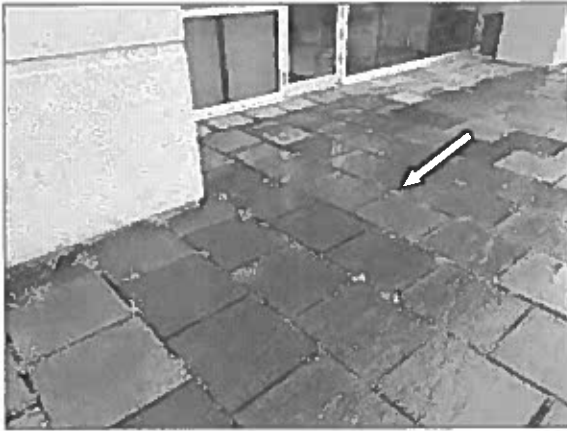
View of the vegetation growth in the interlocking stone pavers noted adjacent to the south elevation of the Site Building.

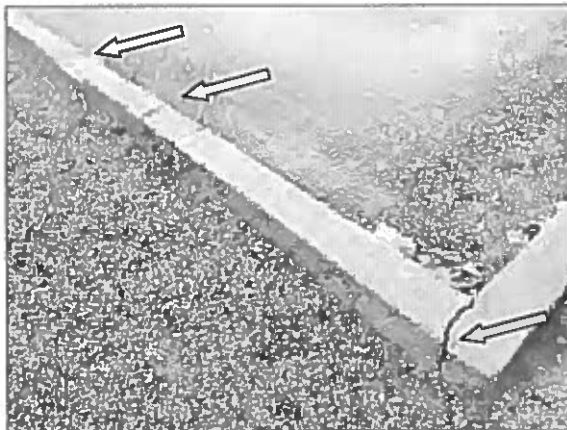
View of typical cracking and deteriorated concrete curb noted on the north portion of the Site.

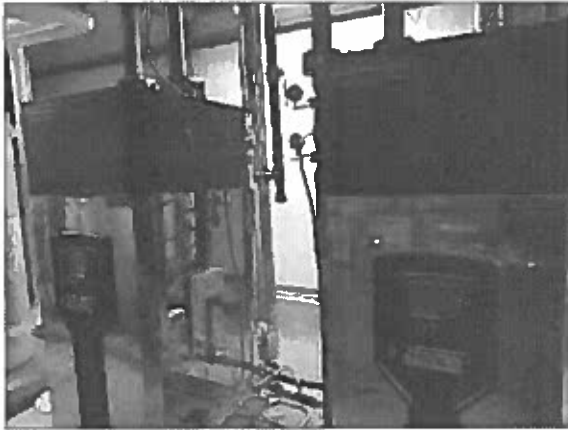
View of the “Camus DynaForce Series” natural gas-fired heating boilers.

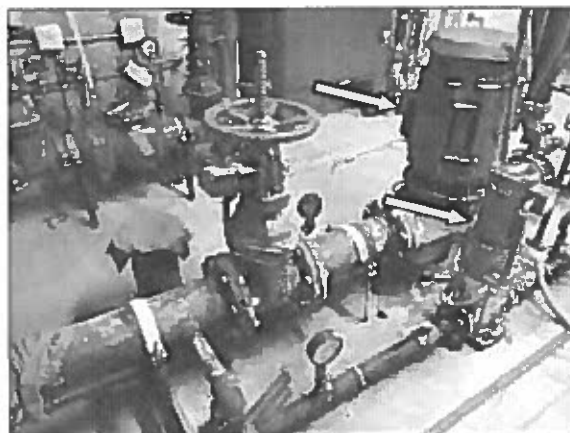
View of the "Plad" centrifugal fire pump and "Wilo" jockey pump.

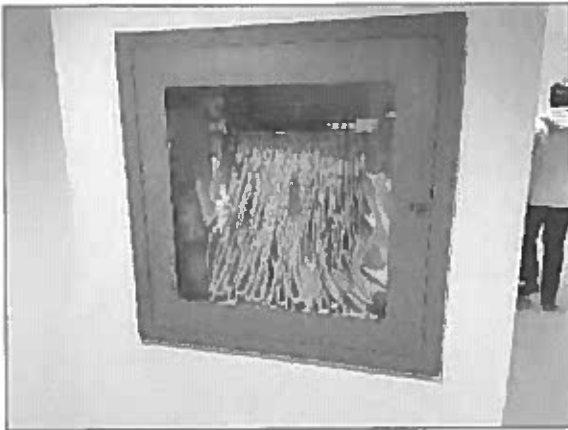
View of a typical standpipe system complete with a fire hose and fire extinguisher located inside the fire hose cabinet.

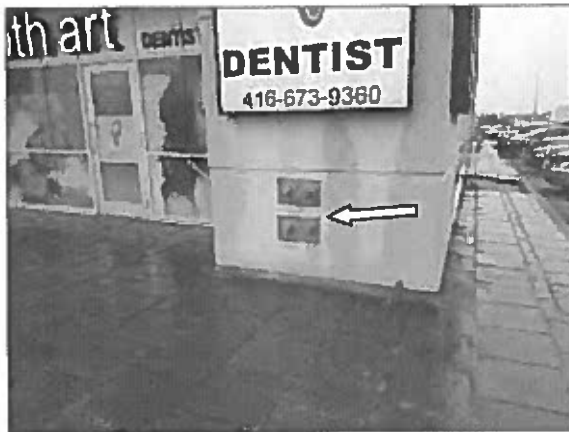
View of the fire department Siamese connections located on the south elevation of the Site Building.

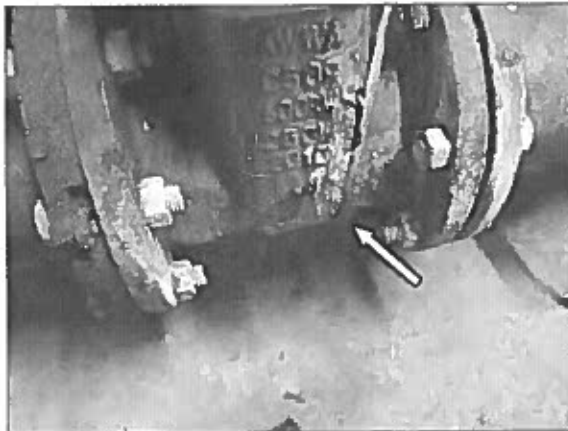
View of the corrosion on the sprinkler main piping noted within the main sprinkler room.

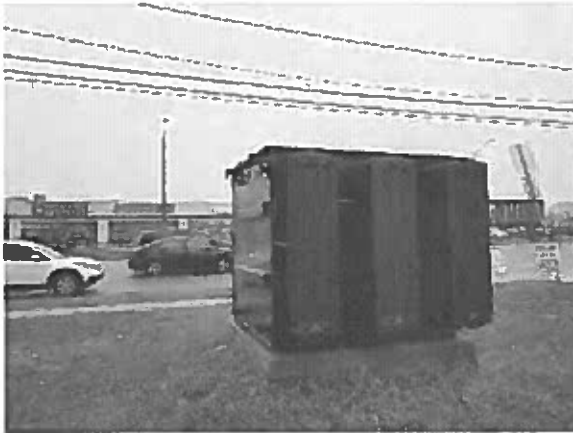
View of the concrete pad-mounted municipal transformer located on the southwest portion of the Site.

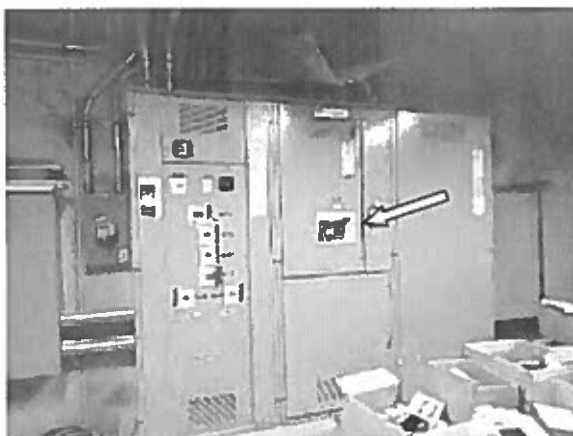
View of the “Eaton” main electrical switchgear and disconnect switch.

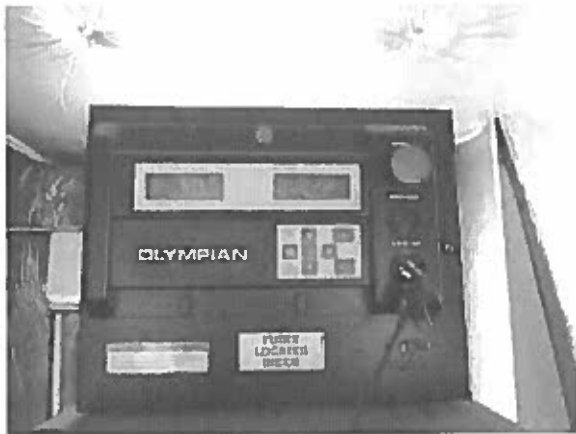
View of the "Olympian" natural gas-fired emergency generator.
